High Ethanol Fuel Endurance:

A Study of the Effects of Running Gasoline with 15% Ethanol Concentration in Current Production Outboard Four-Stroke Engines and Conventional Two-Stroke Outboard Marine Engines

David Hilbert
Mercury Marine
Fond du Lac, Wisconsin

Subcontract Report
NREL/SR-5400-52909
October 2011

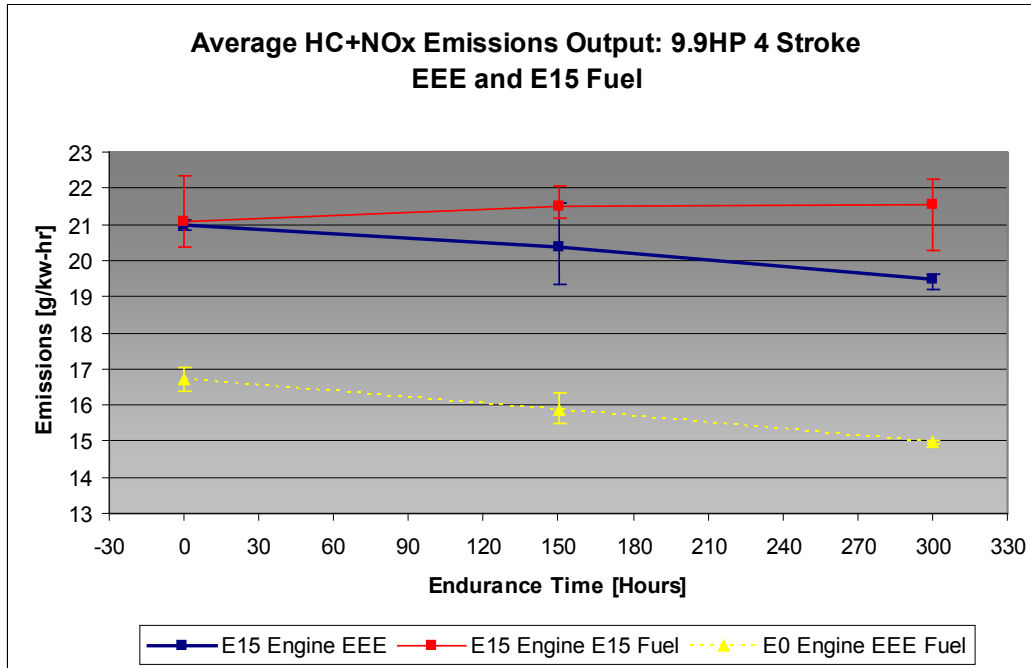
Figure 4: 9.9HP Four-Stroke HC+NOx Emissions Results Summary

the data from the E0 engine (serial number 0R364814). The solid red and blue lines show the emissions data from the E15 engine (serial number 0R352904) using E15 and E0 (EEE) fuels, respectively. Figure 4 shows that the E0 engine had significantly lower emissions than the E15 engine when run on the same fuel. After reviewing the history of the emissions audits on this engine family dating back to its introduction in 2005, both of these engines were within normal production variability.

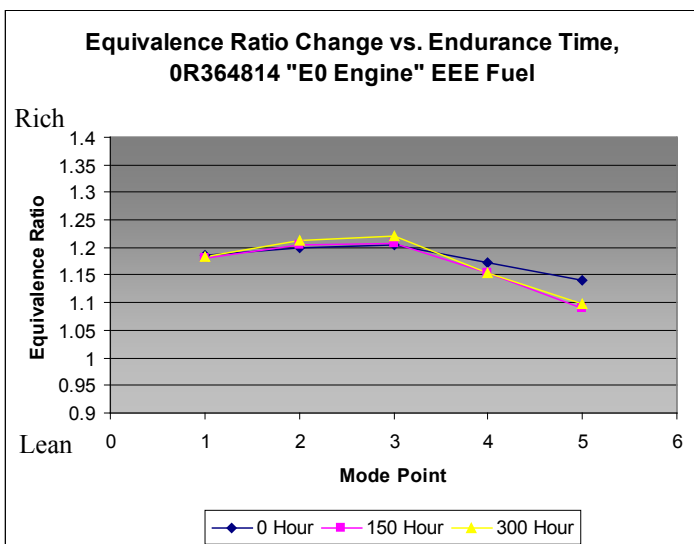
Figures 8 & 9: Change in Equivalence Ratio vs. Endurance Time-EEE Fuel on E0 engine and E15 Engine

The enleanment over time trend predicted from the CO data in Figure 7 was confirmed in Figures 8 and 9 for both the E0 and E15 engines operated on EEE-E0 fuel in both cases. The interesting thing to note was that the primary modes that became leaner were modes 4 and 5. During the end of test inspection on both engines, wear on the throttle plates was found on the sides where the throttle shafts went through the carburetor bodies. The wear caused gaps around the throttle plates which allowed excess air to enter the engines at low throttle opening positions (high manifold vacuum), which included Modes 4 and 5. The amount of wear found was considered normal for the amount of endurance time the engines experienced and was found on both engines.

It should be noted that the E15 engine ran leaner than the E0 engine when operated on EEE-E0 fuel, as can be seen in Figures 8 and 9 from a comparison of the “0 hour” equivalence ratios of both engines. This difference in equivalence ratio is considered to be in the normal production variability of this carbureted engine family.

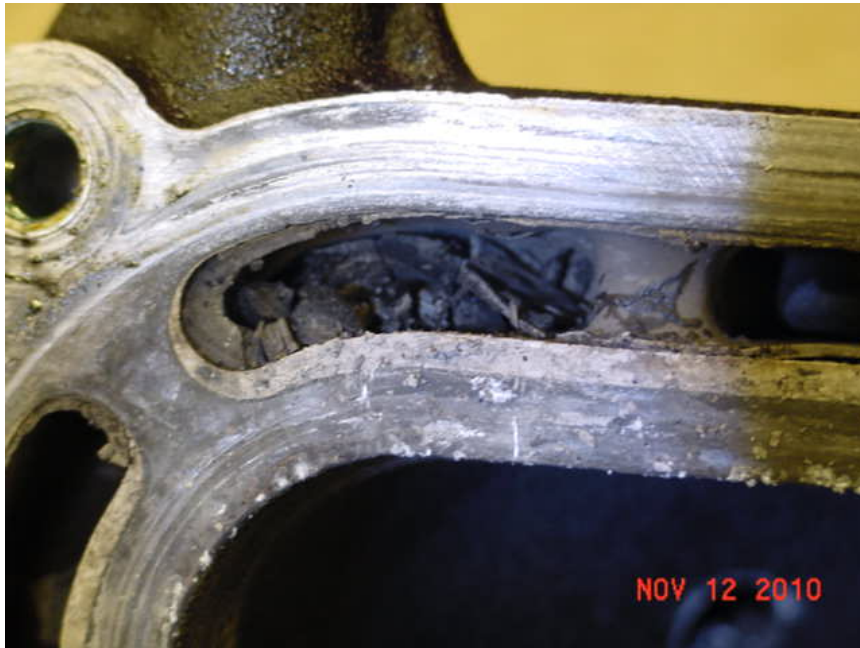
Figure 23: Mineral Deposits in Cooling Jacket, E0 Verado 1B812775A

E0 Engine #2-Test Facility-Induced Failure: An additional engine was obtained to replace the original E0 engine and this engine was given the serial number 1B821775A. This engine did the initial dyno tests and was put on endurance. After 88.7 hours of WOT endurance (98 total engine hours), the engine was automatically shut down by the endurance facility control system for low exhaust gas temperature. Investigation showed water entering the exhaust stream. The engine was then disassembled and a significant amount of mineral deposits were found in the cooling passages, especially in the exhaust collector on the cylinder head. See Figure 23. [Note: For a coolant fluid, outboard engines draw in water from the body of water they are operating in, which in this case was the endurance test tank.] An interaction between

the pH and hardness of the water in the test tank created conditions that precipitated out minerals (primarily calcite) when exposed to the elevated temperatures in the cooling passage, especially near the exhaust collector. The blocked passages prevented adequate cooling in the exhaust collector, which eventually failed the head gasket and allowed water to enter into the exhaust stream. See Figure 24. It should be noted that these water chemistry conditions were specifically caused by the test facility water conditioning and would not be something that the engine would experience in real-world use.

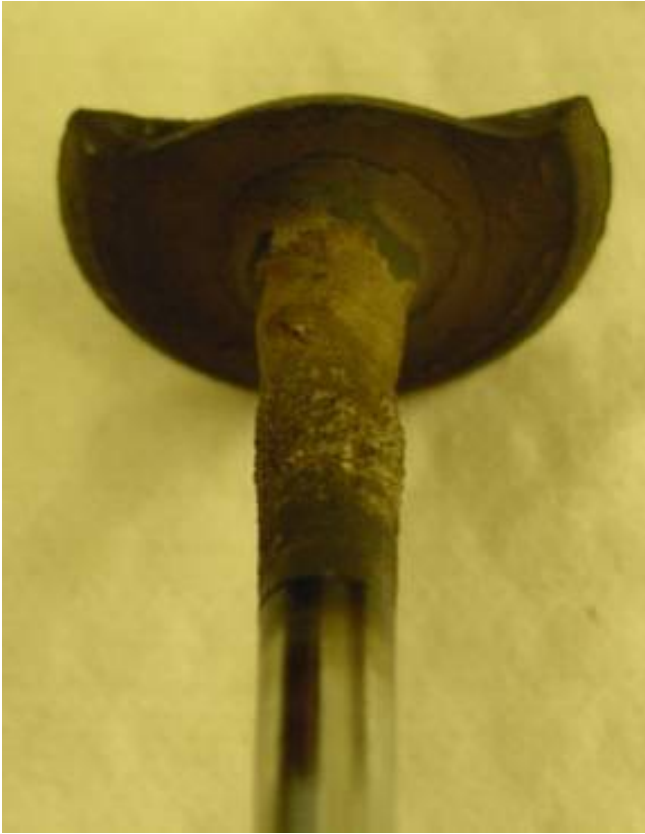
Figure 25: Broken Exhaust Valve from E15 Verado 1B812776, Top Valve in Cylinder 3

E15 Engine: At 285 hours of endurance operation (323 total engine hours), the E15 Verado test engine (serial number 1B812776) was noted to have rough idle after restarting shortly after maintenance was performed. A compression check was performed showing no compression on cylinder 3. During disassembly a broken exhaust valve was found in cylinder #3. Further investigation found that the other exhaust valve on cylinder 3 had developed a crack, as well as one

of the exhaust valves in cylinder 6. See Figures 25 and 26. NOTE: The images shown in Figure 26 of the cracked exhaust valves had been cleaned of deposits prior to photography.

- The E15 engine failed 3 exhaust valves close to the end of the endurance test.
 - Metallurgical analysis showed that the valves developed high cycle fatigue cracks due excessive metal temperatures.
- The pistons on the E15 engine showed indications of higher operating temperatures compared to the E0 engine's pistons as evidenced by the visual difference in carbon deposits.
- The E15 engine generated HC+NO_x values in excess of the Family Emissions Limit (FEL) when operated on E15 fuel, but did not exceed that limit when operated on E0 emissions certification fuel.

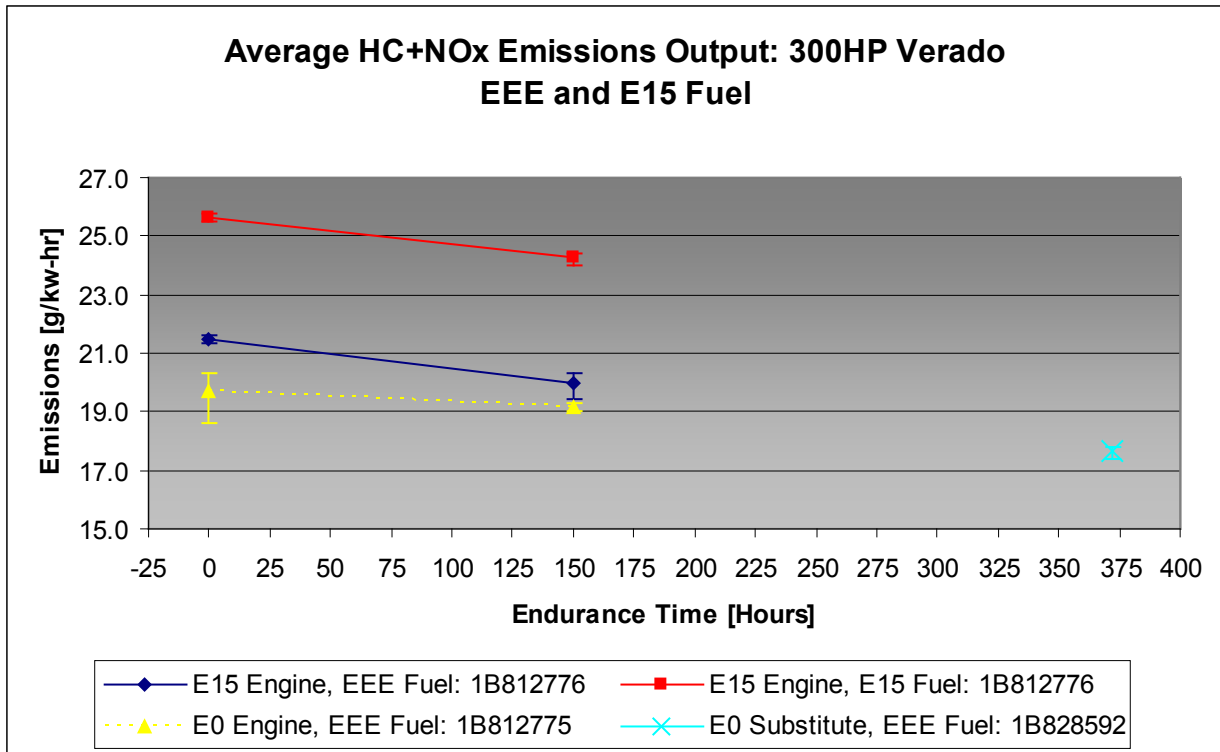
Figure 34: 300HP Verado HC+NOx Emissions Results Summary

Due to failures of both the E0 and E15 engines, a complete analysis of the deteriorated emissions was not possible. However, with the data available several conclusions could be made. Figure 34 shows a graph of the Verado emissions that were collected. As was the case for the 9.9HP emissions data plots, each data point on the curve represents the average emissions value of the 3 emissions tests performed at each interval with error bars showing the range of the 3 emissions tests. The dashed yellow line shows the data from the original E0 engine (serial number 1B812775). The solid red and blue lines show the emissions data from the E15 engine (serial number 1B812776) using E15 and E0 (EEE) fuels, respectively. The single point in light blue at 372 hours shows the end of test emissions results for the substitute E0 engine (EEE fuel, serial number 1B828592). The graph shows a generally declining HC+NOx trend for the 2 original engines which is typical of Verado engines. The declining emissions trends on both engines would suggest that the ethanol fuel blend did not adversely affect the emissions deterioration on the Verado engine. The most notable aspect of the emissions output on the E15 engine was the fact that the total HC+NOx on E15 fuel was above 25 g/kw-hr, whereas the value on EEE-E0 was 21.5 g/kw-hr. The Family Emissions Limit (FEL) was set to 22 g/kw-hr for this engine family. A Verado engine generating 25 g/kw-hr would have failed an emissions audit. The increase in emissions can be primarily attributed to a significant increase in NOx due to the lean operation. Since the Verado is a highly boosted engine it is very sensitive to NOx generation due to changes in equivalence ratio. However, there was also an increase in HC emissions due to the E15 fuel, which would not be expected with a leaner equivalence ratio.

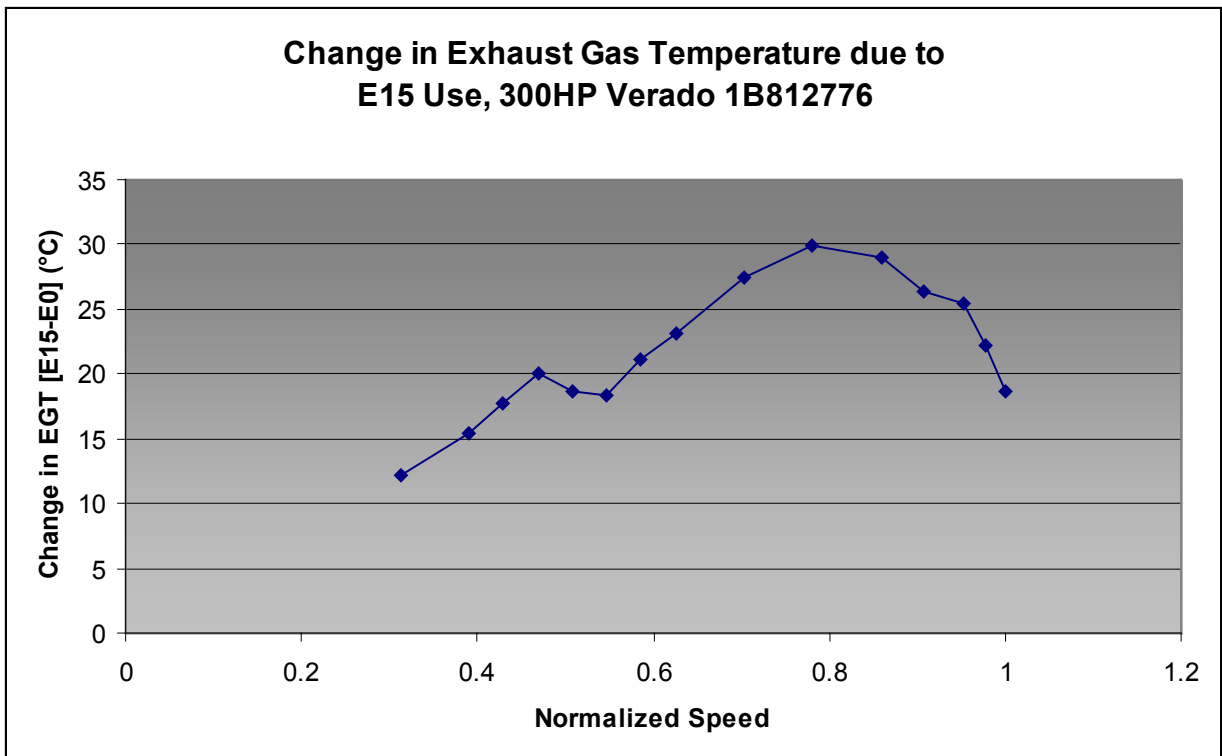
Figure 40: E15 Engine-Exhaust Gas Temperature Change at Wide Open Throttle, EEE-E0 to E15 Fuel

Figure 40 shows the difference in exhaust gas temperatures during power runs at the midpoint check on the 2 different fuels. There was up to a 30°C increase in EGT when operating on E15 fuel.

- The exhaust gas temperature increased 17°C at wide open throttle as a result of the leaner operation when using E15 fuel. Higher combustion temperatures may have caused observed piston hardness reductions. Lack of pre-test hardness measurements prevented a conclusive assessment.

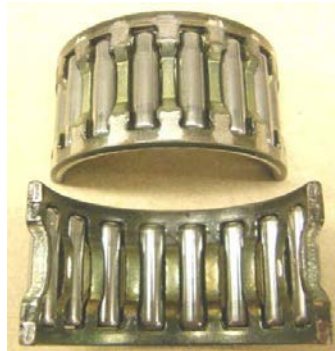
Figure 44: 200HP EFI Bearing Failure Pictures

The E15 endurance engine failed at 283 total engine hours and had accumulated 256 hours of WOT endurance at the time of failure. Upon inspection it was found that the big end connecting rod bearing had failed on cylinder 3. The rod cap was still bolted to the rod after the failure. This engine family uses a fractured rod cap design with a roller bearing (typical for a two-stroke vs. a plain bearing in a four-stroke). Images of the remaining bearing cage and the damaged rod along with undamaged pieces for reference are shown in Figure 44. No rollers were found during teardown and were likely ejected from the bearing and made their way through the power cylinder and out the exhaust. There was extensive damage to the top of the piston on cylinder 3 indicating that the rollers went through the power cylinder. Due to the extensive damage to the bearing and connecting rod (since it failed at rated speed, full power) and the fact that not all of the pieces were recovered, root cause of the bearing failure was not conclusively determined. Little is known about the effects of ethanol blends on oil/fuel mixing and dispersion on total loss lubrication systems, such as the one on this engine family. More investigation is needed to understand if ethanol would negatively impact the lubrication systems on two-stroke engines.

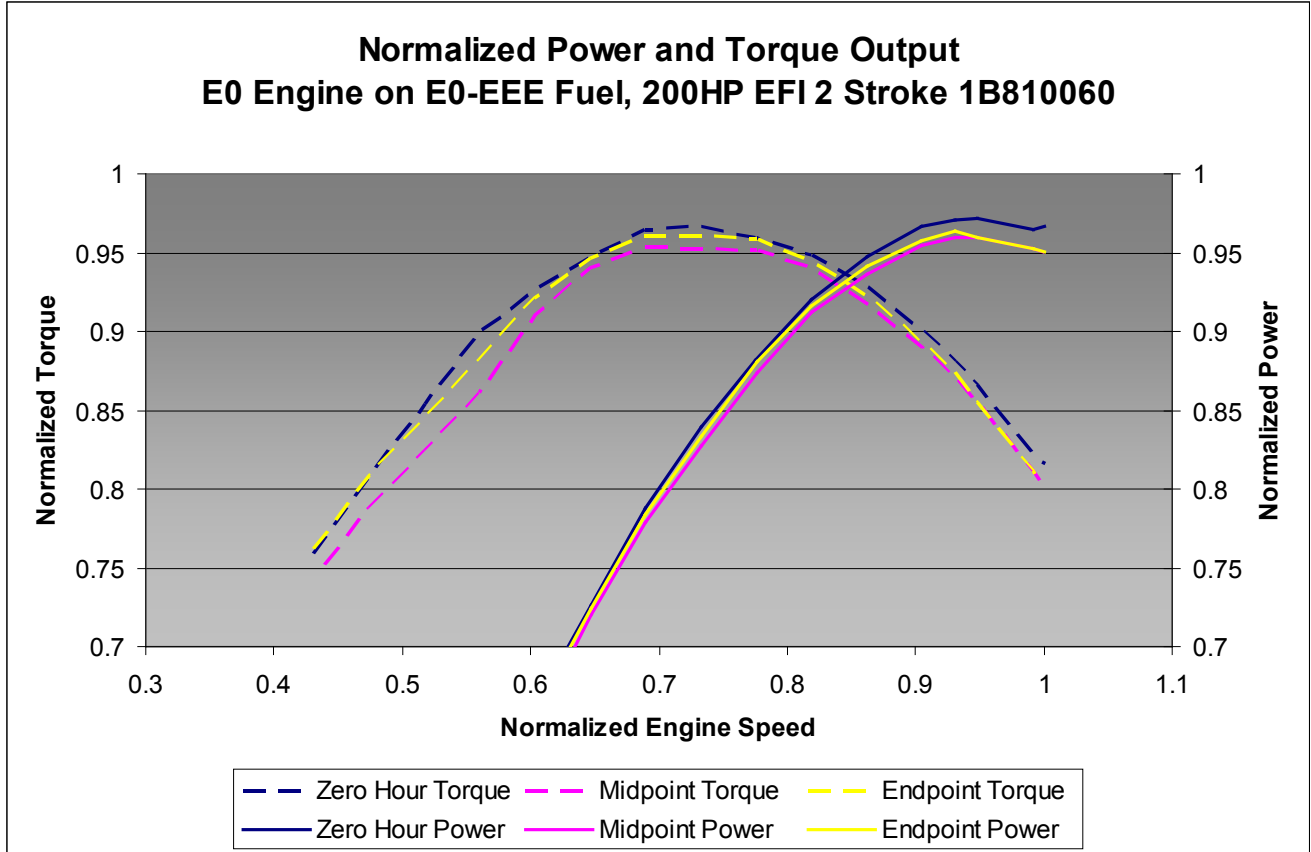
Figure 47: E0 Engine Power and Torque Output at Endurance Check Intervals-EEE-E0 Fuel

The power and torque data (corrected per ISO 3046-1) from the E0 200HP EFI engine are shown in Figure 47. There were slight differences in the curves, but the changes from zero hours to 300 hours were less than 1% for both peak torque and peak power.
